# INSTALLATION MANUAL: Faulty rotor batch 210 outer rotor system

Dear valued customer, we recently had a faulty batch of outer rotor flywheels. The magnets inside the rotor are polarised the wrong way around.

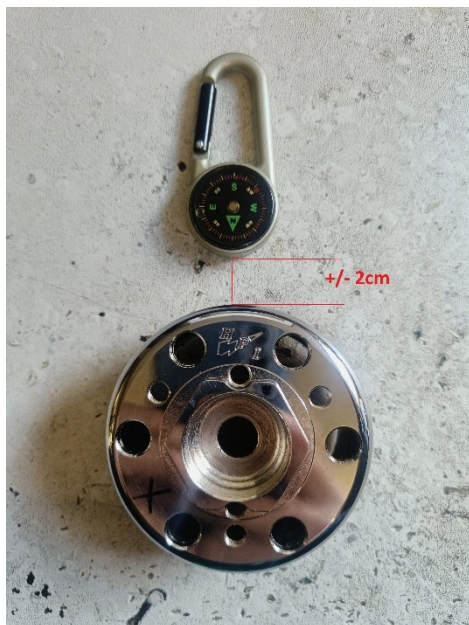
This picture above shows a **WRONG** rotor, mind the HPI logo on the top. At the top of the rotor, where the HPI logo is located the North pole of the compass is facing the rotor.

In a good rotor, the magnetic field is reversed. So the south should face the HPI logo on the rotor.

You can easily check this with a compass. If you have a faulty rotor, you can solve this problem by turning the rotor 90° when installing it on the bike.

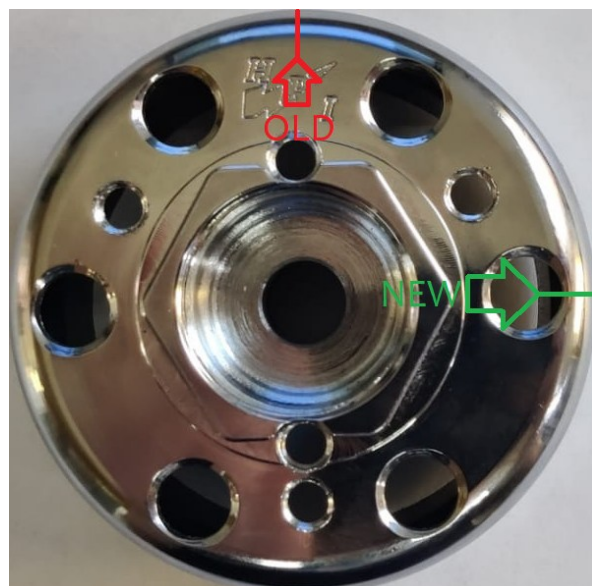
The old marking (red) is where the HPI is located check on the side of the rotor. The new marking should be made 90° to the right (green) make this marking with a marker or small iron saw.

Take the new set of marking lines as described in the drawing on the right. Again, mind the position of the HPI logo.
